Analysis of the Suitability of Road Signs and Markings for One-Way Traffic on Jalan Kartini, Tegal City

Veda Widyadhana Aji¹, Rania Ratu Khairani², Febyana Dwi Salsa Abidin³, Suprpto Hadi^{4*}, Brasie Pradana Sela Bunga Riska Ayu⁵

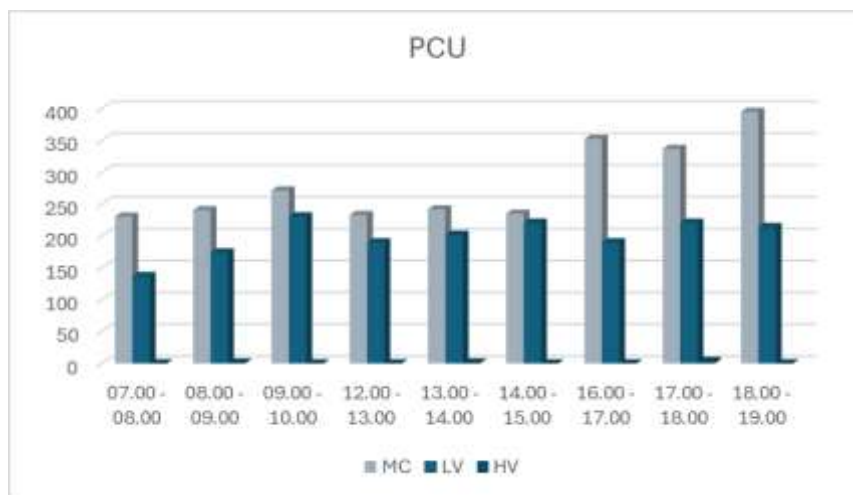
Figure 1. Traffic Counting Data

Traffic counts on Thursday, 29 May 2025 on the Jalan Kartini in Tegal City road section for morning observations obtained peak hours at 09.00-10.00 with a total vehicle volume of 502.5 PCU/hour. The afternoon peak hour was obtained at 13.45-14.45 with a total vehicle volume of 462.75 PCU/hour. In the evening, the peak hour is obtained at 18.00 - 19.00 and the total vehicle volume reached 609 PCU/hour. Therefore, peak hour can be obtained in the evening at 18.00 - 19.00 with the highest of total vehicle volume is 609 PCU/hour.

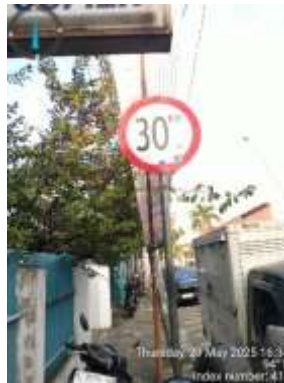
Figure 2. Vehicle speed limit sign for 30 km/h on Kartini road section.

The result of the design speed obtained is 30 km/h in accordance from the existing speed limit signs on the road section with the signs placed 50 m far away from roadside section. This result has been adjusted to the function of Jalan Kartini in Tegal City based on survey data.

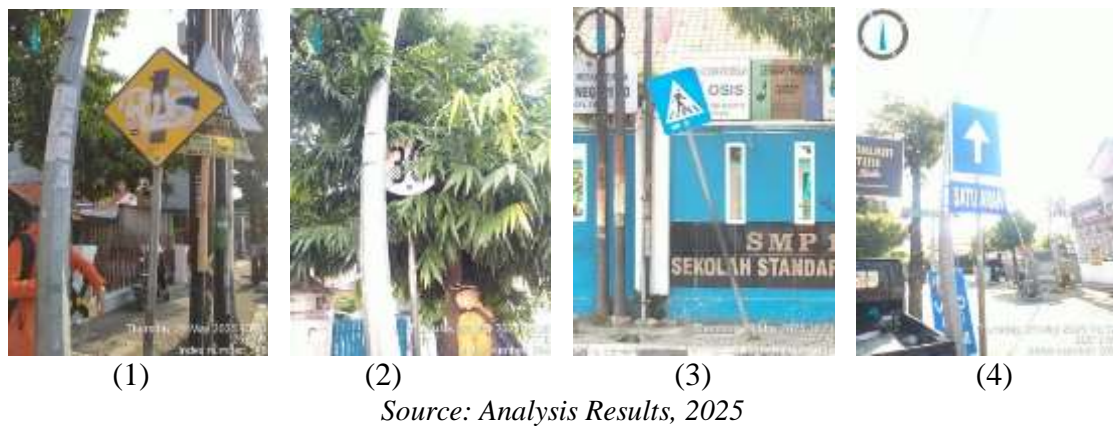
Figure 3. (1) Intersection warning sign covered with spray paint (2) Speed limit sign obstructed by vegetation (3) Crosswalk sign pole is tilted (4) One-way implementation sign

The results of the traffic sign inventory survey on Jalan Kartini in Tegal City found that the physical condition of most signs requires serious attention. Many signs were damaged, such as faded colors, covered with spray paint, illegal stickers, and bent or tilted poles. For example, the three-sided intersection warning sign at STA 0+061 is covered in spray paint. Meanwhile, signs indicating the location of the hospital at STA 0+154, parking restrictions at STA 0+166 to STA 0+179 have many stickers attached that interfere with visibility. Every traffic sign must be in good condition, not faded, not covered by other objects, and easily visible to the driver from a distance of at least 100 m [16]. Signs that are in a damaged or unreadable condition clearly do not meet the stipulated provisions and have the potential to reduce the effectiveness of information conveyed to road users, as well as the potential for traffic violations [24].

Some signs were found to be placed in inappropriate positions. One of them is the maximum speed limit sign at STA 0+309 which is covered by trees, as well as the sign indicating the location of bus stop facilities at STA 0+323 which is only 25 cm from the road shoulder. This placement is not in accordance with the provisions stating that signs must be located in a location that is easily visible, not obstructed by other objects, and not too close to the vehicle lane so as not to be prone to being hit [16]. In addition, the slope of the sign pole as at STA 0+341 also reduces the effectiveness of conveying information to the driver.

Overall, the evaluation of the physical condition, placement, size, and spacing of signs on Jalan Kartini in Tegal City showed that most signs required repair and adjustment to comply with applicable technical standards. Improving and standardizing signs according to the guidelines of the applicable provisions, it is expected that the information conveyed is more effective, well read, and can support the smoothness and safety of road users [17]

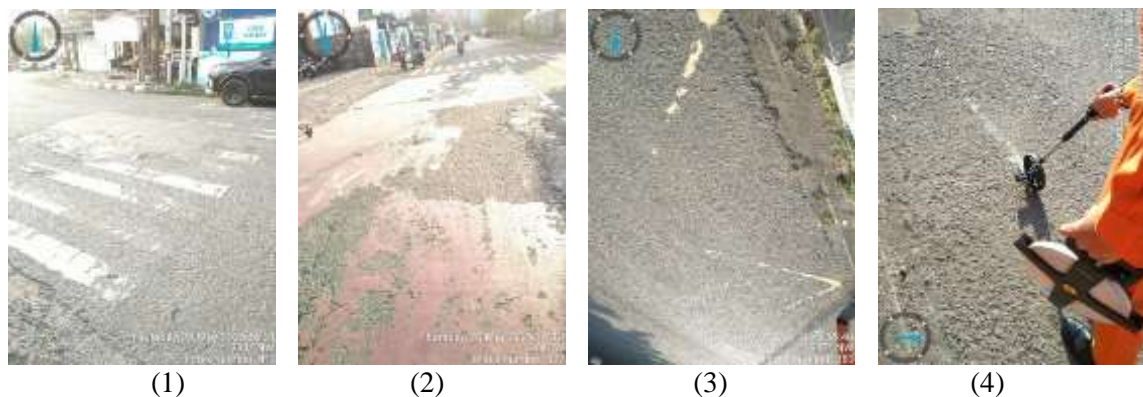
Figure 4. (1) Faded zebra crossing markings (2) ZOSS markings paint peeling off (3) Faded no-parking markings (4) Faded road shoulder markings

Results of the road markings survey on Jalan Kartini found that most of markings were in a faded physical condition and were not clearly visible to road users. For example, the roadside markings at STA 0+064 had faded, as well as the parking restriction markings at STA 0+154, 0+173, and 0+313 which were all in the form of yellow sinuous lines but no longer looked sharp. Similar conditions were also found on *zebra crossings* at STA 0+339, 0+363, and 0+439 as well as ZOSS markings at STA 0+313 and 0+376 which faded and lost visibility. Referring to PERMENHUB No. 67 of 2018 concerning Road Markings, each marking should have a condition that is clearly visible both day and night and must not fade or be covered by other objects. The existing condition of the markings on the road section can be said to not meet the eligibility standards as required by the regulation.
